Effect of Soil Settlement on Wall Cracks and Failures in the City of Shari, Saudi Arabia, Case Study

ABSTRACT. This paper describes a case study for the causes of cracks and ruptures that emerged in the houses of the City of Shari, AlQassim region. The structures of this city built using the load wall bearings system. Loads of bearing masonry buildings usually have walls arranged at a fairly uniform spacing to carry gravity loads to the foundation without addition of columns. This study is divided to two parts; the first part discusses the field geotechnical investigation of the construction site. The second part presents the results of a parametric study for the effect of soil settlement as well as the positions and sizes of the wall openings on the existence of the wall cracks. The results showed that, the construction of houses almost at or very near to the ground surface with no rigid tie-beams under the walls which could help in resisting the differential settlement affects their safety. The opening definitely reduces the stiffness of the wall and subsequently reduces the failure load and increases deflection at the same load level. The finite difference-based code FLAC and t

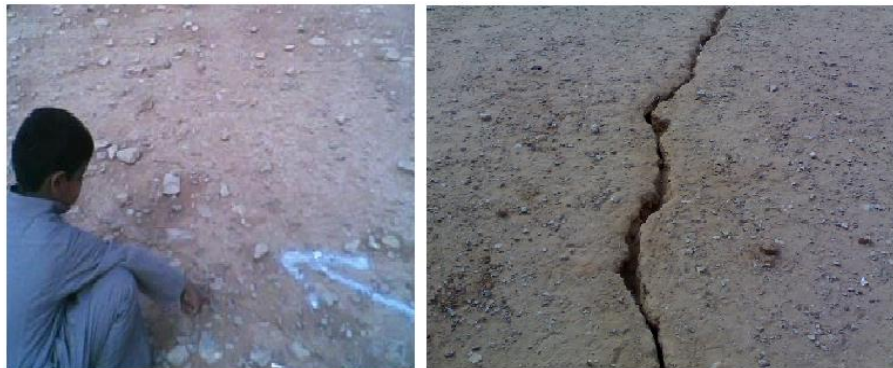
- The cracking lies in an area that is highly inhabited with people and passes through their houses.
- The existence of the ground surface cracking that reaches more than 10 cm in width and up to 10 cm in depth and varies in length and may reach up to 30 m in length, Figure (2).
- The houses in the area are built with wall bearing systems founded on weak strip plain concrete footings.
- The strip footings are constructed on or at very near level to the ground surface.
- The houses roofs are supported by steel-sections posts which in turn are held against the walls.
- The cracks and ruptures appeared anchored in the fences and walls of some buildings especially around the wall openings (windows and doors), as shown in Figure (3).

Fig. (2). Ground surface cracking

The study for the soil profile at the site showed that increasing the moisture in the collapsible soil, due to rainfalls and the surrounding huge farms, led to soil layers collapsing and consequently the emerging of the ground surface cracking and ruptures. The size and rate of these crakes depend on the applied loads on the soil from the superstructures constructed on it which increase as the surface loading and stress increase.

Therefore, it could be concluded that the probable cause of these cracks are the collapsible nature of the soil, the presence of high concentrations of calcite, gypsum, calcium carbonate, and iron oxides which are all soluble agents causing potential failure upon exposing to water. In addition to these factors, the fluctuation in the movement of the groundwater levels in the area due to wells operation and rainfall led to the emerging of the ground surface cracking and rupture.

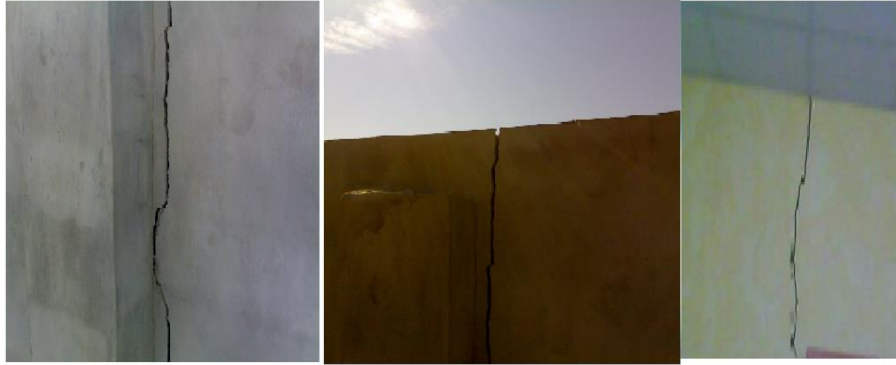
Fig. (3). Cracks in the fences surrounding the houses

Since it is noticed that the damaged houses are constructed almost on or at very near to the ground surface with no rigid tie-beams under the walls which could help in resisting the differential settlement. Moreover, the surface load concentration

due to the existence of the steel-sections posts which are used to support the houses roofs increased the surface stresses. Therefore, these damages in the village houses may be attributed to the nature of collapsible soil in the site, surface load concentrations, and the absence of tie-beams contribute to the sever damage in the walls of these houses.

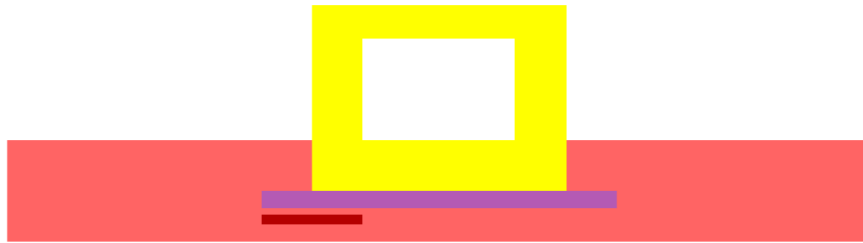
The mesh used is 0.1m x 0.1m, total width = 17m total height = 7m. The dimension of the opening is 3m x 3m, top beam is 1m thick, foundation level is -1.5m with foundation thickness = 0.5m, columns are 1m thick. Ground beam is 2.0 m thick. The main soil properties are shown in Table 1, a problematic soil with a certain dimension 30 cm x 3 m is shown in Figure 4, and a parametric study was done for three set of properties for the problematic soil.

**Fig. (4). Regions used in the Study**

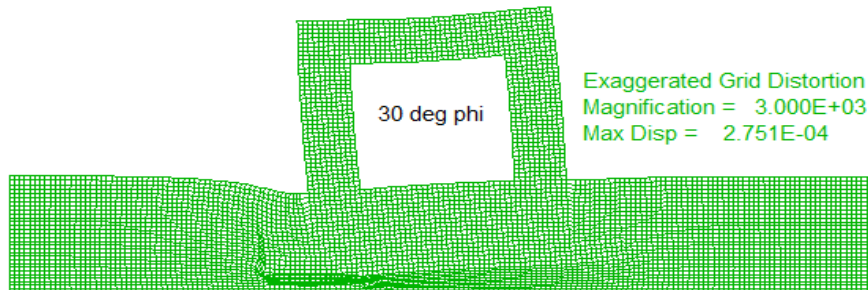
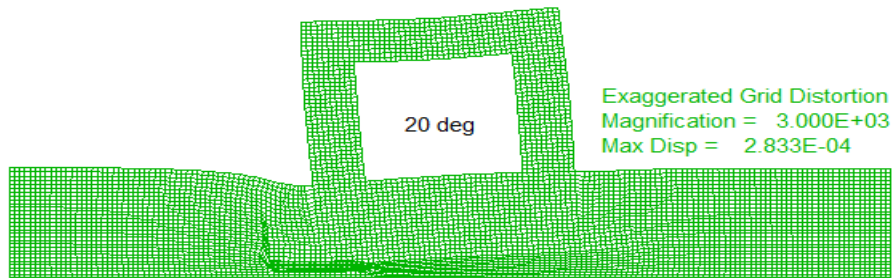
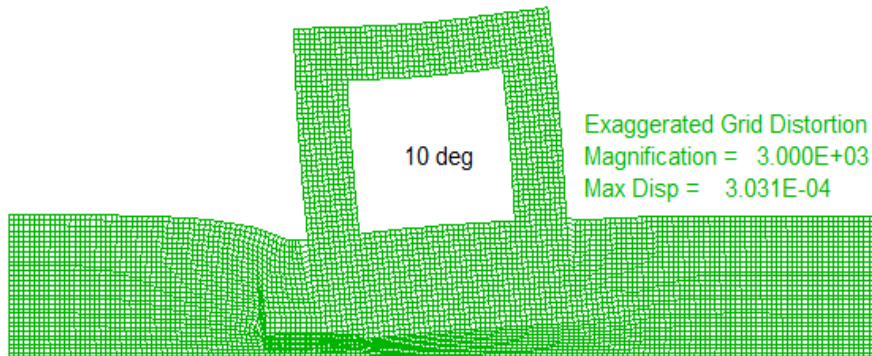
Exaggerated grid distortions for the three cases are shown in figures 5, 6, and 7. Maximum displacements are 0.2751mm, 0.2833mm, and 0.3031 for the three cases A, B, C respectively. It is clear as the soil properties deteriorate the displacement increases. For all cases a tilt appears for the structure indicating the effect of the problematic soil.

**Fig. (5). Grid distortion, Soil A**

Fig. (6). Grid distortion, Soil B

Fig. (7). Grid distortion, Soil C

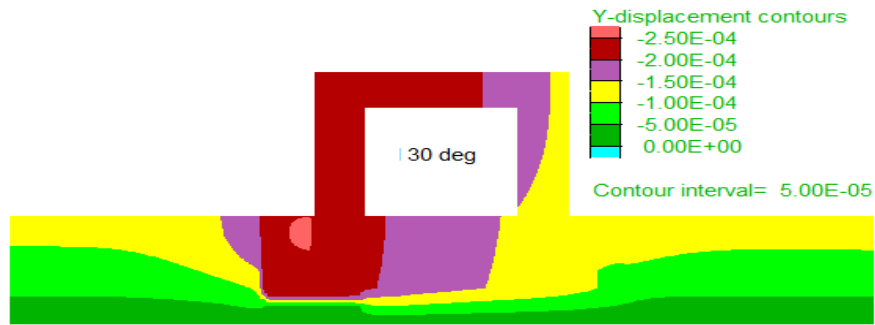
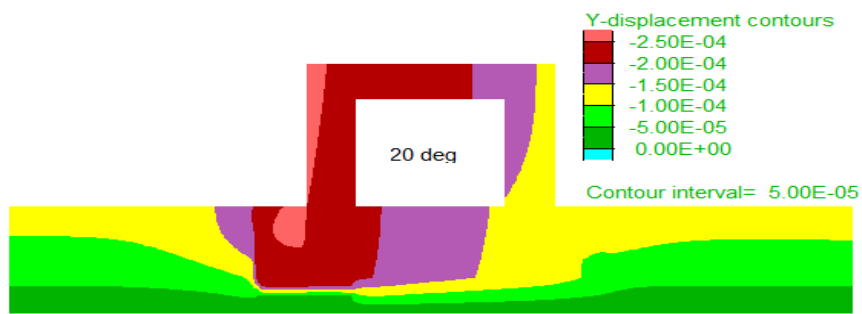
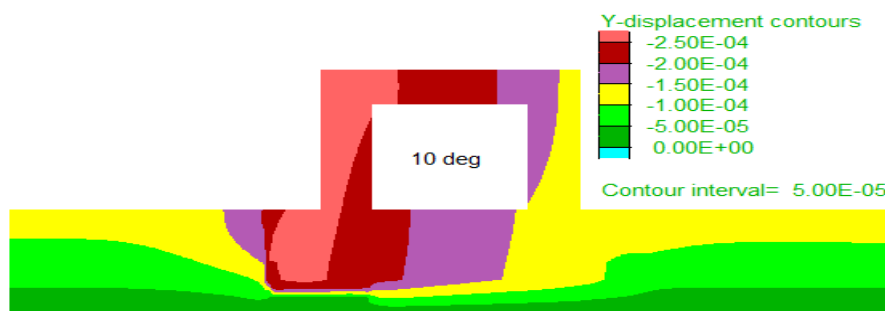
Vertical (Y) displacement contours for the three cases are shown in Figures 8, 9, and 10. Maximum displacements are on the left hand side of the structures for all cases. It is clear as the soil properties deteriorate the vertical displacement increases as can be seen from the increase of the pink area on the left hand side of the structure indicating the effect of the problematic soil. Table 2 shows the vertical displacement at the top left hand side point of the structure for the three cases.

Fig. (8). Vertical displacement, Soil A

Fig. (9). Vertical displacement, Soil B

Fig. (10). Vertical displacement, Soil C

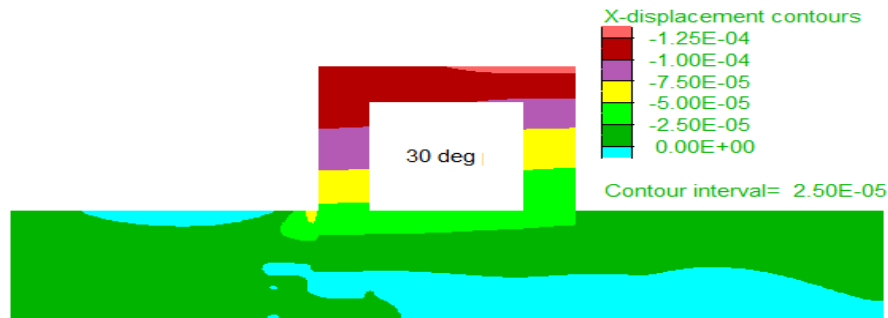
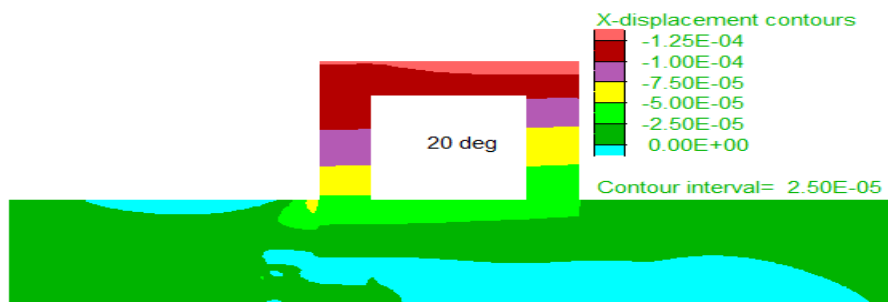
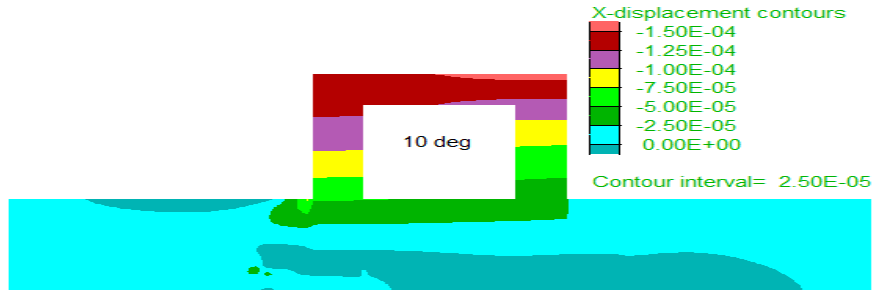
Horizontal (X) displacement contours for the three cases are shown in figures 11, 12, and 13. Negative values indicate the movement towards the left hand side of the structures for all cases. It is clear as the soil properties deteriorate the horizontal displacement increases as can be seen from the increase of the pink area on the upper right hand side of the structure indicating the effect of the problematic soil. Table 3 shows the horizontal displacement at the top right hand side point of the structure for the three cases.

Fig. (11). Horizontal displacement, Soil A

Fig. (12). Horizontal displacement, Soil B

Fig. (13). Horizontal displacement, Soil C

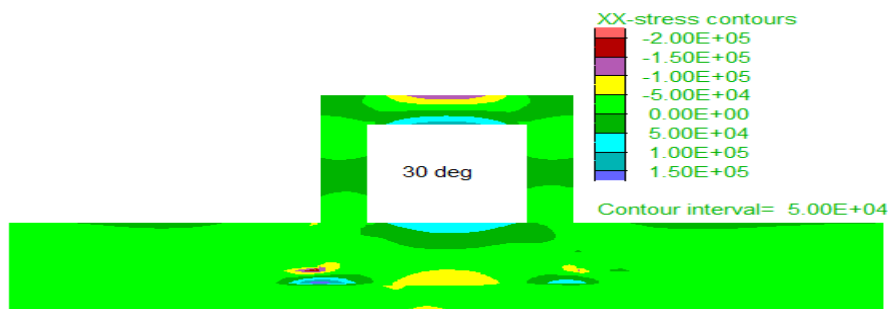
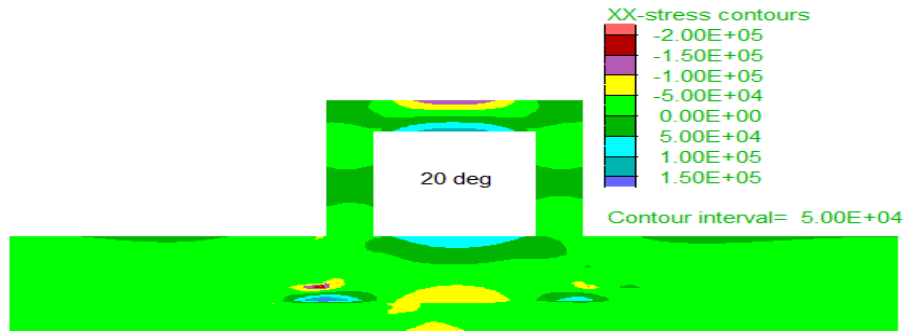
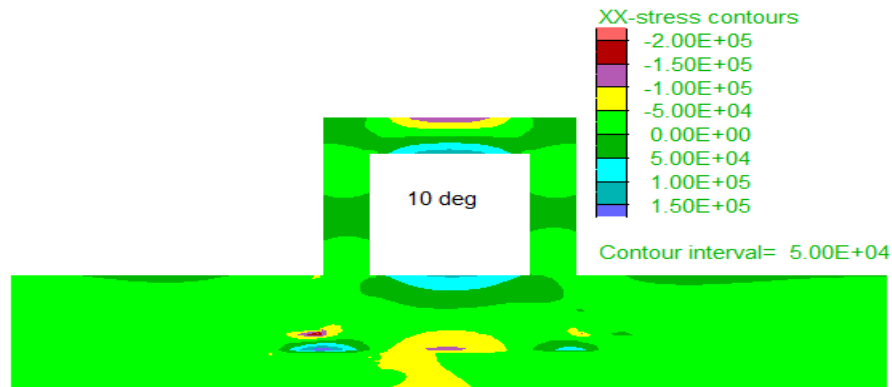
Horizontal (X) stress contours for the three cases are shown in Figures 14, 15, and 16. Negative values indicate compression, and positive values indicate tension. Table 5 shows the horizontal stresses at the middle lower fibers of the top beam (point 85, 61) and at the lower right hand side fibers of the left column (point 70, 31) for the three cases. It is clear as the soil properties deteriorate the horizontal stresses increases as can be seen from table 4 indicating the effect of the problematic soil.

Fig. (14). Horizontal stresses, Soil A

Fig. (15). Horizontal stresses, Soil B

Fig. (16). Horizontal stresses, Soil C

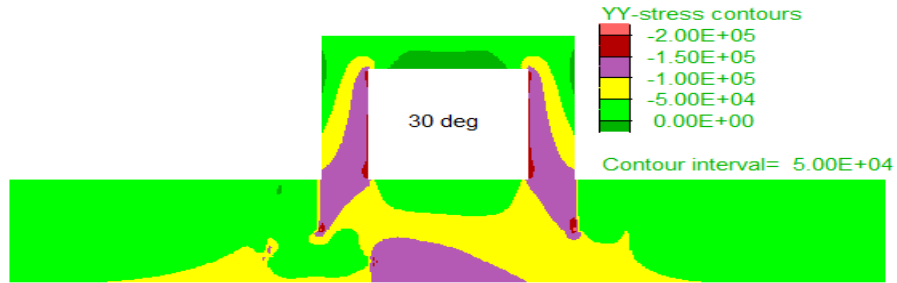
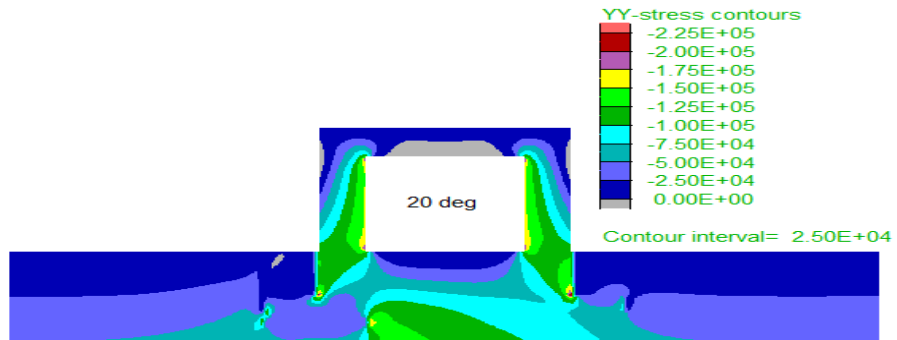
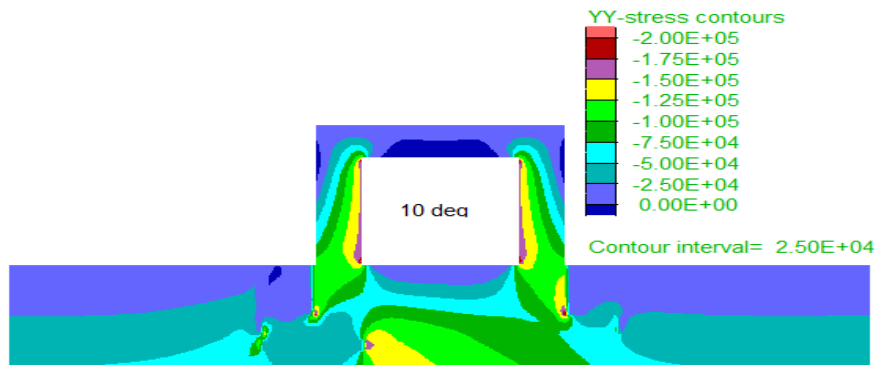
Vertical (Y) stress contours for the three cases are shown in figures 17, 18, and 19. Negative values indicate compression, and positive values indicate tension. Table 6 shows the vertical stresses at the lower right hand side fibers of the left column (point 70, 31) for the three cases. It is clear as the soil properties deteriorate the horizontal stresses increases as can be seen from table 4 indicating the effect of the problematic soil.

Fig. (17). Vertical stresses, Soil A

Fig. (18). Vertical Stresses, Soil B

Fig. (19). Vertical stresses, Soil C

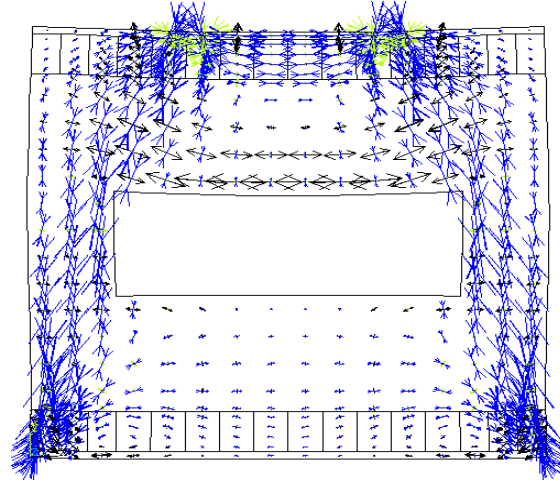
For models with opening increase in the width direction, the load path was deviated around the opening. The failure of these models occurred at the bearing regions of the lintel. The cracks increased around the lintel of the opening and propagated towards the loading points and supports of the model. Figure (20) and (21) demonstrates the internal stresses trajectories for models at 75% from the failure load.

Fig. (20). Internal stresses trajectories for model W3

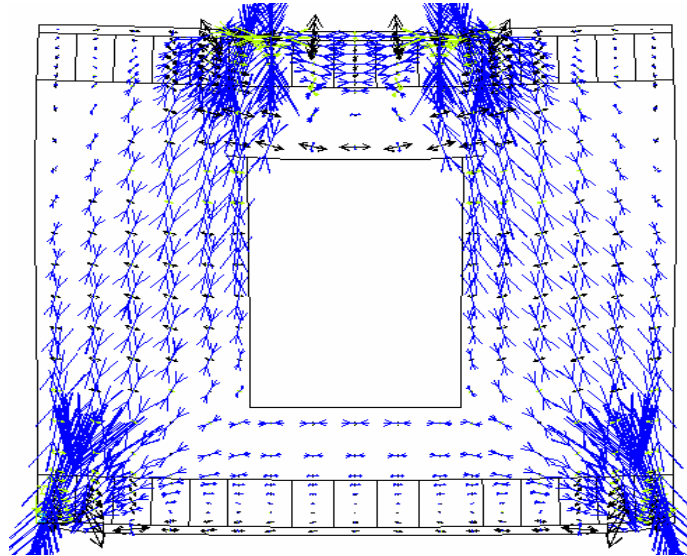
The behavior of models with central opening (increase in the height of opening) was observed that nearly have the same trend as models without opening; because the opening size was not intersecting the load path. Load path of these models were kept similar as load path observed for models without opening. The failure happened at the supports of model and propagated diagonally towards the loading points.

Fig. (21). Internal stresses trajectories for model V2
